**Report on sedimentology
cores from Lower Passaic
River, RM 10.9**

Final version September 2012

Sediment cores; sedimentology; point-bar deposits; Lower Passaic River; River Mile 10.9; New Jersey, USA

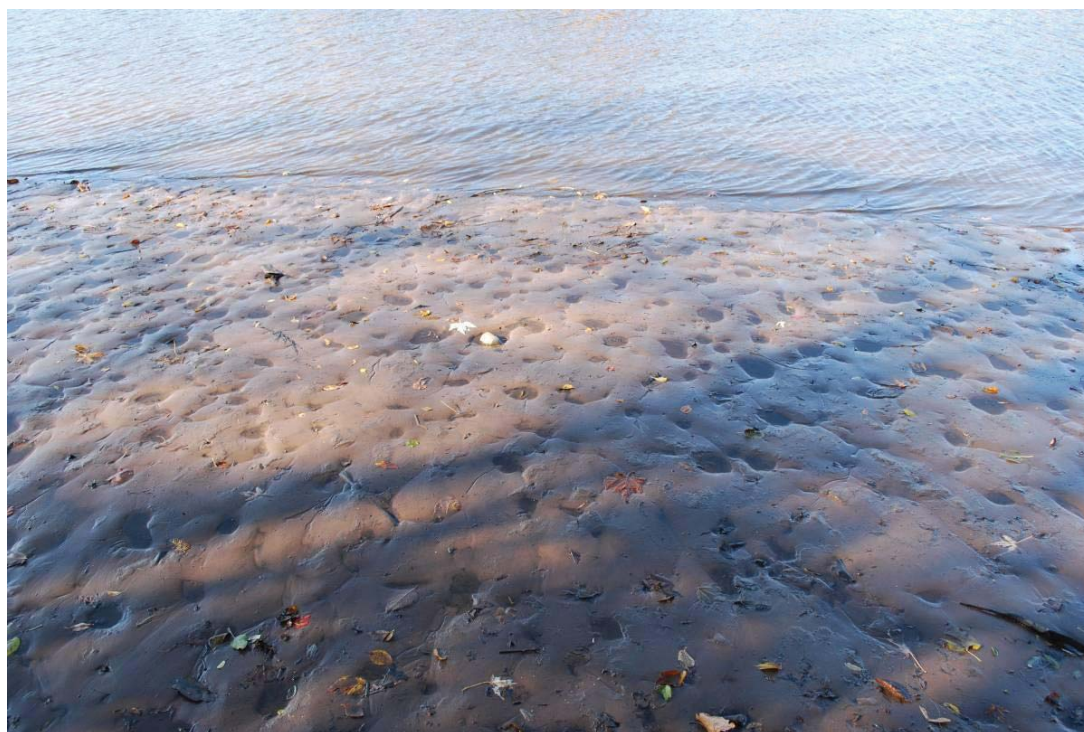
Photo 2: washed-out ripples on the sandy intertidal part of the point bar near RM 10.9.

During Low Tide the top of point bar was exposed. The supratidal part of the point bar consisted of sand with gravel and stones, the intertidal part was sandy, with washed-out ripples at the surface (Photo 1-3). This area was scattered with debris, such as gravel, boulders, timber, tree trunks, tree leaves, concrete lumps and slabs, plastic buckets, etc. Between RM 10.7 and 10.8, a distinct zonation in the intertidal zone was visible; a zone of sandy deposits in the high intertidal zone was bordered by a zone of sand with scattered organic debris on top in the lower intertidal zone (Photo 1). The latter zone suggests a more muddy composition, which is not the case, see Photo 3. However, deposits with a 'sandy appearance' sometimes proved to be muddy (Photo 4).

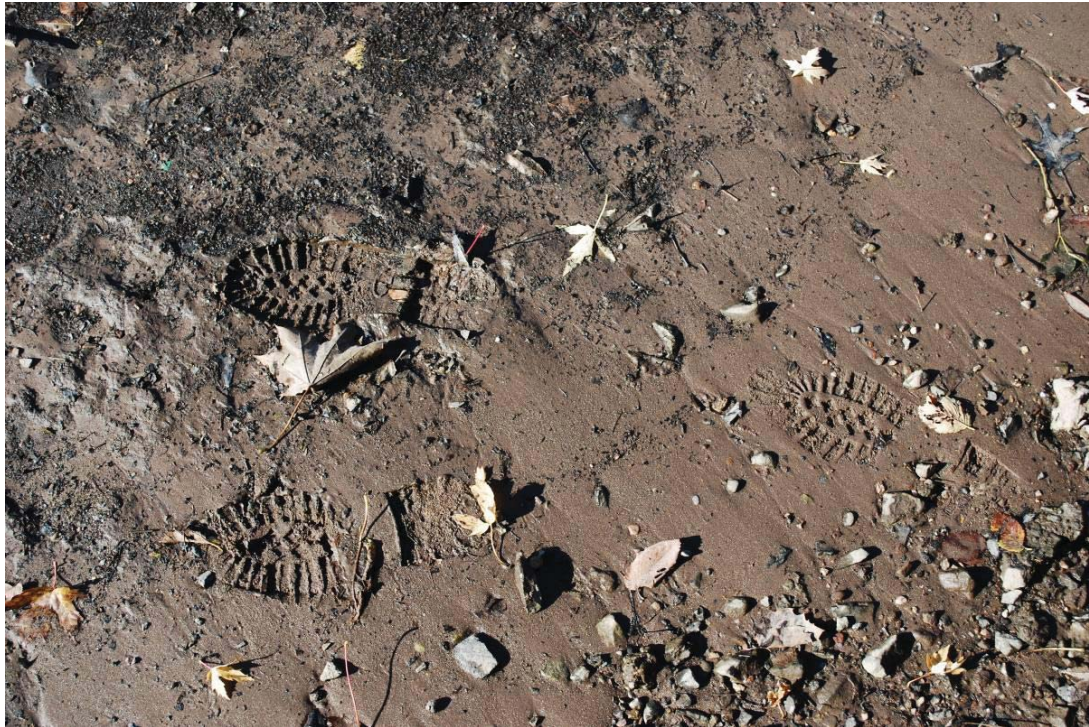
Photo 3: sandy point-bar deposits near the high-water line at RM 10.7. The sediment in the upper left corner of the photo is darker due to organic debris deposited on the sandy surface.

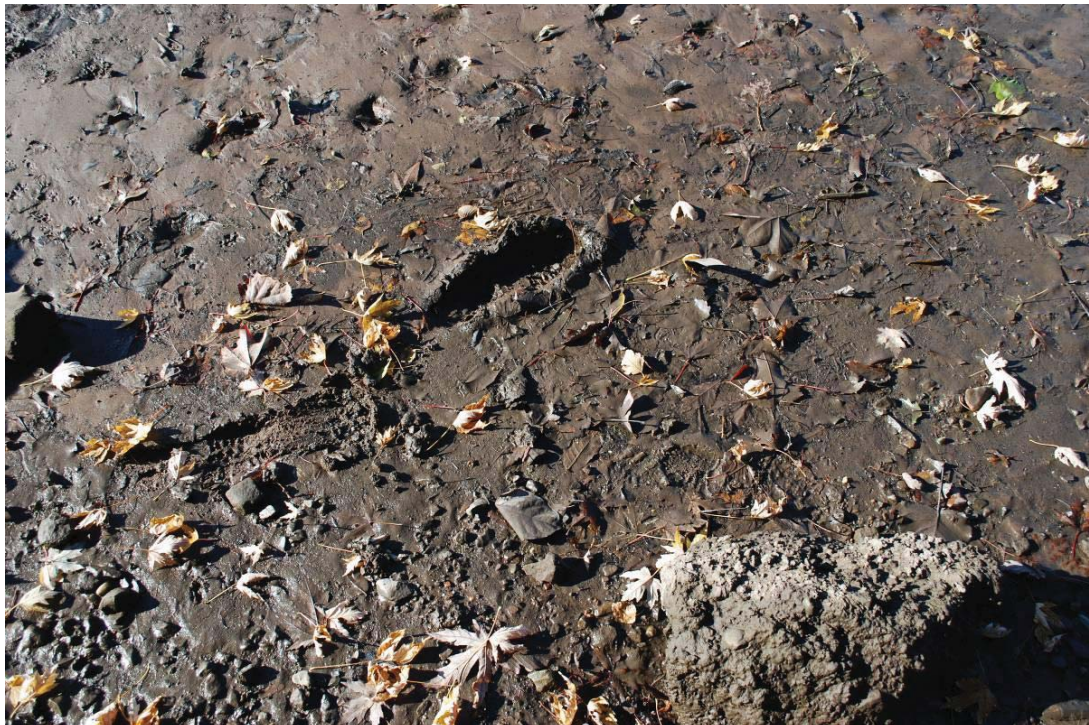
Photo 4: muddy sediments near the high water line at RM 10

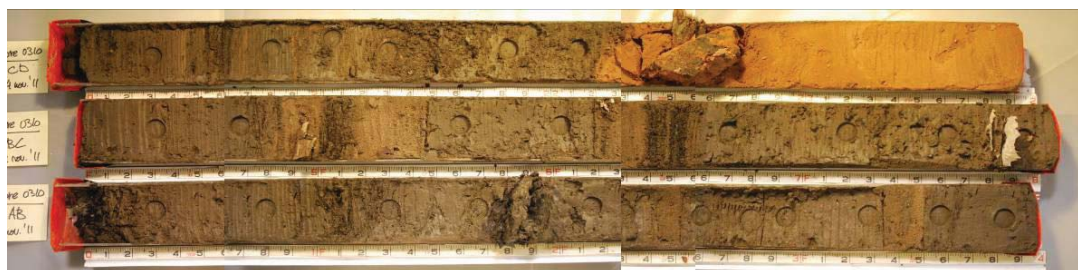
Core 0310

The 'native' sediment in core 0310 consists of dark reddish brown (2.5YR-3/4), very fine to fine sand. The top of the native sediment is disturbed; a lump of asphalt and plastic were pushed into the sediment during coring. The reddish brown sediment is overlain by over 7 feet of very dark brown (10YR-2/1,2) to very dark gray (10YR-3/1) to black (10YR 2/1) silty to sandy mud that is locally parallel or low-angle cross-laminated and contains layers of well-sorted fine sand that are up to 0.3 m thick. Moreover, layers of organic debris and dispersed plant remains and wood are found. Artifacts, such as plastic, a plastic bag (filled with mud), candy wrappers and pieces of aluminum, occur both in the mud and in the sand layers. The strength of the mud increases with depth. The upper 3 feet of the core consists of soft, black, silty to sandy mud that is both parallel and low-angle cross-laminated. The strength of the mud in this interval does not increase with depth. Organic debris occurs in layers and dispersed in the mud and layers of packed tree leaves are found (0-0.15 ft; 1.7-2.0 ft). A layer of well-sorted fine-grained sand occurs from 2.4 to 2.5 feet.

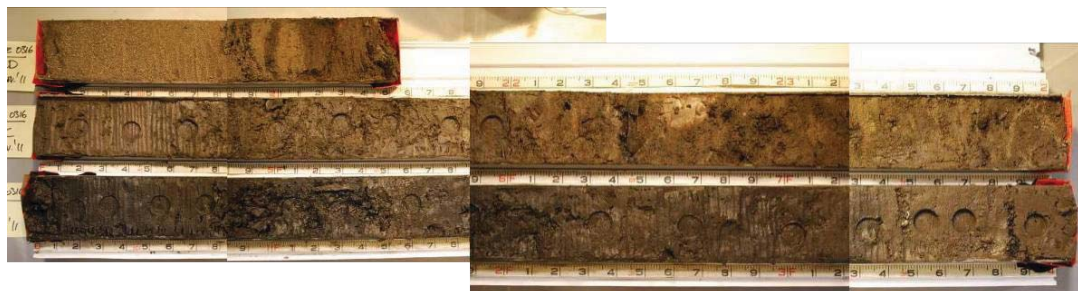
Core 0316 does not reach into native sediments. The lowermost deposit is a very dark gray (10YR-3/1) stiff clay that contains layers of organic detritus. This is overlain by 3 feet of fine to medium sand with a messy appearance; pebbles, clay and mud balls, pieces of wood, lumps of organic material occur in the sand. The sand itself is moderately rounded and sorted and grayish in color. It shows some distorted low-angle cross-lamination and has an organic clay layer at the bottom. A six-foot thick layer of black to very dark gray (10YR-3-2/1) mud overlies the sand. The mud contains plant remains and thin (mm-thick) layers of organic debris and fine sand. The mud contains sandy intervals and organic debris occurs dispersed through the mud. Small, fragile white shells, probably of Ostracods, are found at 3.4 feet and pieces of anthracite occur in the lower part. The strength of the mud increases slightly with depth over the upper 4 feet and more or less constant between 4 and 6 feet. The upper 0.75 feet of the mud is soft, black in color and has a pebble and a sand ripple at the top. Organic debris occurs in layers and dispersed.

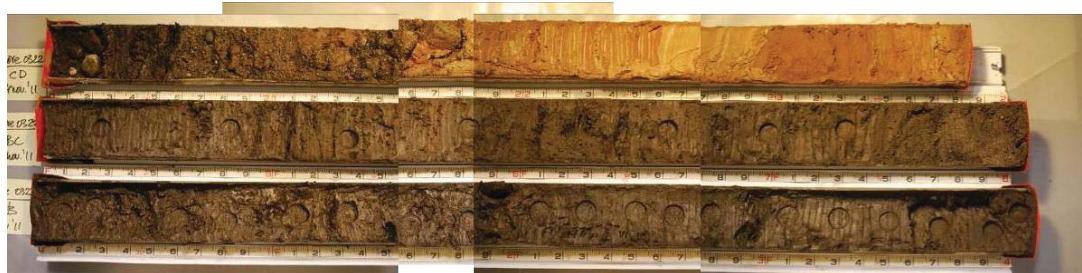
Core 0322 contains a 'native' silty clay that shows color banding: reddish brown (2.5YR-4/4), alternating with weak red (10R-4/3), on top of a dark reddish brown (2.5YR-3/4) very fine sand. The lower part of this sand is finer and clayey, is reddish brown (2.56YR-4/3) in color and shows some color banding too. The color banding is possibly a reflection of original layering of the sediment. The top of the 'native' sediment is disturbed, probably due to coring. It is overlain by a foot of poorly sorted, greyish medium to coarse sand that shows cross-bedding with layers of fine to medium pebbles and some disturbance caused by coring. A 0.3 feet thick layer of very dark gray (10YR-3/1) silty mud with low-angle cross-lamination with organic debris bounding the lamination, and wood remains overlies the sand. On top of this comes 0.8 feet of very dark gray (10YR-3/1), well-sorted and rounded, medium to coarse sand that contains clay balls and organic debris. It shows cm-scale cross-bedding with organic debris bounding the cross-beds and the lower 0.2 feet consists of coarse, moderately rounded but badly sorted sand with medium to very coarse pebbles. This sand is overlain by 6 feet of soft mud that contains intervals of organic debris and plant remains, thin layers of well-sorted and -rounded sand and dispersed pebbles and organic debris. The color of the mud changes from black at the top to very dark gray (10YR-3/1). The mud contains packed tree leaves (6.15 to 6.30 ft), low-angle cross-lamination (from 5.9 to 6.5 ft) and pieces of aluminum (at 6.5 ft). The strength of the mud slowly increases with depth. The high value at 4 feet, the bottom of section AB, is likely due to consolidation during storage of the core. The upper 1.5 feet of the core consists of very soft, black silty mud that contains some small branches and pebbles.
